INDOOR AIR QUALITY ASSESSMENT

**John C. Page Elementary School
694 Main Street
West Newbury, Massachusetts**

Prepared by:
Massachusetts Department of Public Health
Bureau of Environmental Health Assessment
Emergency Response/Indoor Air Quality Program
June 2003

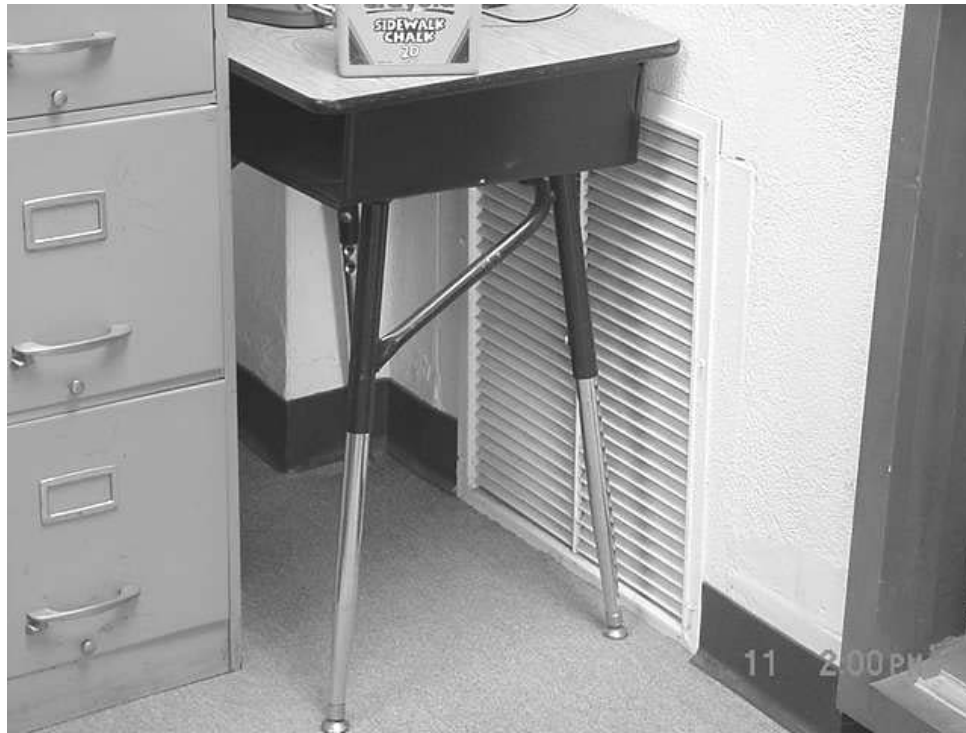
Picture 1

The mechanical exhaust ventilation system consists of ceiling and wall-mounted exhaust vents (see Picture 1) connected to exhaust fans on the roof. Exhaust fans were obstructed by items stored in classrooms in a number of areas. None of the exhaust vents were functioning during the assessment. Without exhaust ventilation, indoor air pollutants can build up and lead to indoor air quality/comfort complaints.

Classroom Exhaust Vent Connected to Rooftop Motor

1. Examine each univent for function. Survey classrooms for univent function to ascertain if an adequate air supply exists for each room. Consider consulting a heating, ventilation and air conditioning (HVAC) engineer concerning the calibration of univent fresh air control dampers school-wide.
2. Remove all blockages from univents and exhaust vents to ensure adequate airflow. Clean out interiors of univents regularly.
3. Examine mechanical exhaust vents building-wide for function and activate if operable.
4. To maximize air exchange, the BEHA recommends that the ventilation system operate continuously during periods of school occupancy, independent of classroom thermostat control.

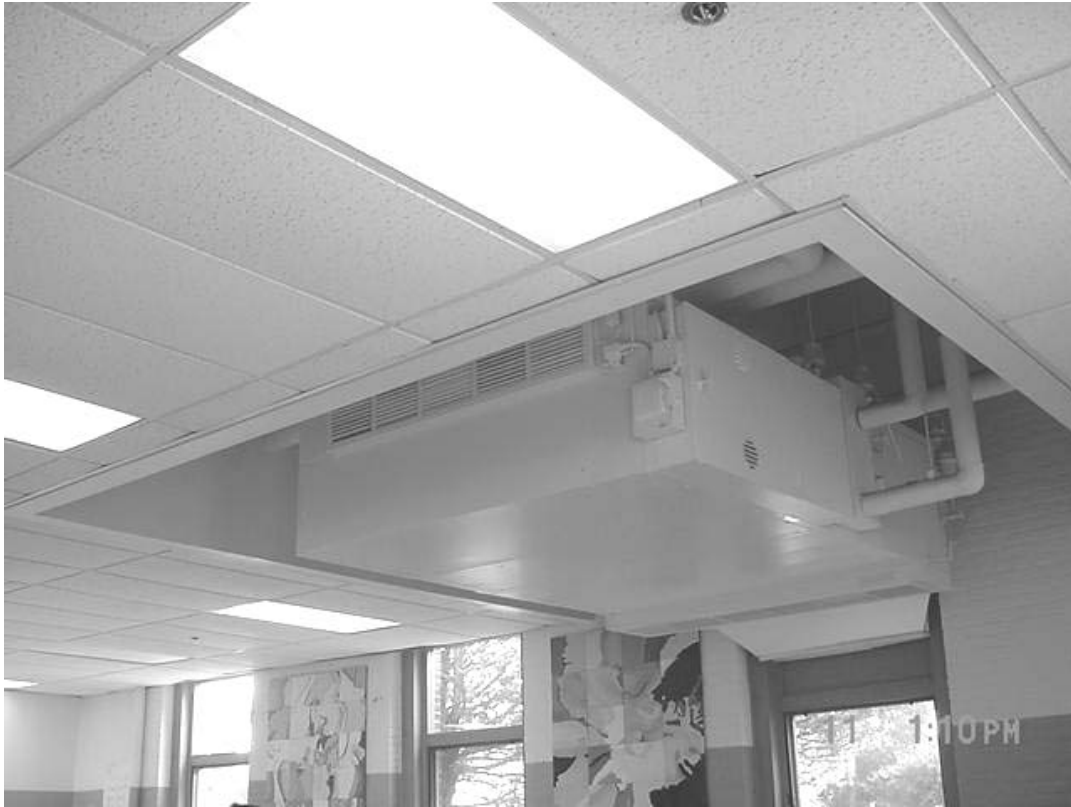
Picture 2

Mechanical ventilation in the cafeteria is provided by a ceiling-mounted air handling unit (AHU). The AHU was deactivated and as with the univents, appeared not to have been operating for some time. In addition, the installation of a dropped ceiling around the AHU would limit airflow in the cafeteria upon activation (see Picture 2).

Drop-Ceiling Tile System Installed around Cafeteria AHU Obstructing Airflow

1. Based on the age, physical deterioration and availability of parts of the HVAC system, the BEHA strongly recommends that an HVAC engineering firm fully evaluate the ventilation system building wide.
2. Although no obvious evidence of water damage and/or microbial growth was detected, the potential for mold growth in carpeting exists. Based on previous BEHA experience, carpeting in below grade areas can be prone to mold growth due to prolonged moisture exposure, e.g. high relative humidity (> 70%) for extended periods of time (>24 hrs). To avoid this occurrence, consideration should be made to remove carpeting from basement

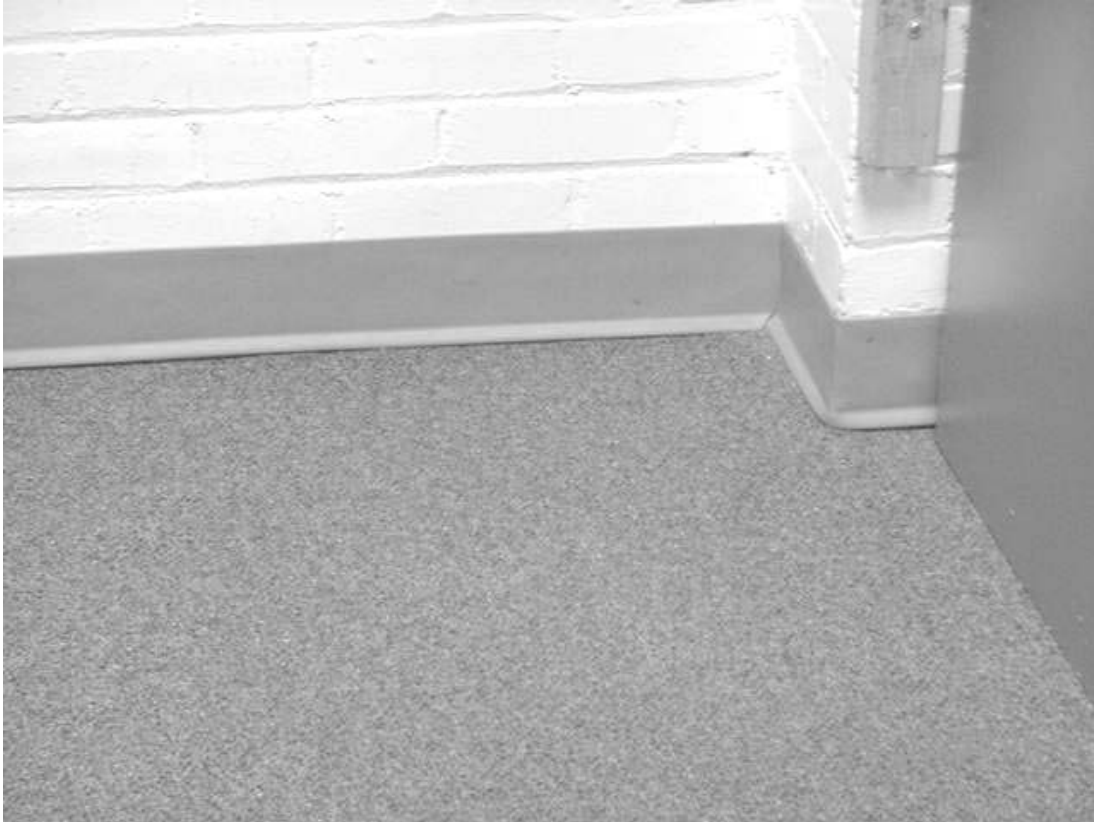
Picture 4

It should be noted however, that carpeting is not generally recommended in areas prone to high relative humidity. During the spring and summer of 2002, New England experienced a stretch of excessively humid weather during three periods in May, July and August. For example, outdoor relative humidity from July 4, 2002 through July 12, 2002 ranged from 73 percent to 100 percent, without precipitation (The Weather Underground, 2002). As stated previously, mechanical ventilation in the building appeared to have been deactivated for some time. Without dilution and removal via the mechanical ventilation system, excess heat and moisture can build up inside the building, particularly during summer months. The accumulation of moist air can lead to condensation on floor surfaces becoming “trapped” beneath carpeting and behind rubber coving along the base of walls (see Picture 4), which can subsequently lead to microbial growth. Carpeting is a porous material and can provide a source of microbial growth especially if wetted repeatedly. The American Conference of Governmental Industrial Hygienists (ACGIH) recommends that carpeting be dried with fans and heating within 24 hours of becoming wet (ACGIH, 1989). If not dried within this time frame, mold growth may occur. Water-damaged carpeting cannot be adequately cleaned to remove mold growth. The application of a mildewcide to moldy carpeting is not recommended.

Wall to Wall Carpeting and Rubber Coving along Base of Walls in the Basement

areas. If visible mold and/or moisture are present, clean with an appropriate microbiological agent. Consider replacing basement carpets with an alternative sound attenuating floor tile.

3. Remove rubber baseboard coving during carpet removal and examine for fungal growth. If visible mold and/or moisture are present, clean with an appropriate microbiological agent.
4. Examine the feasibility of providing exhaust ventilation for custodial closets and teachers' work rooms equipped with photocopiers.

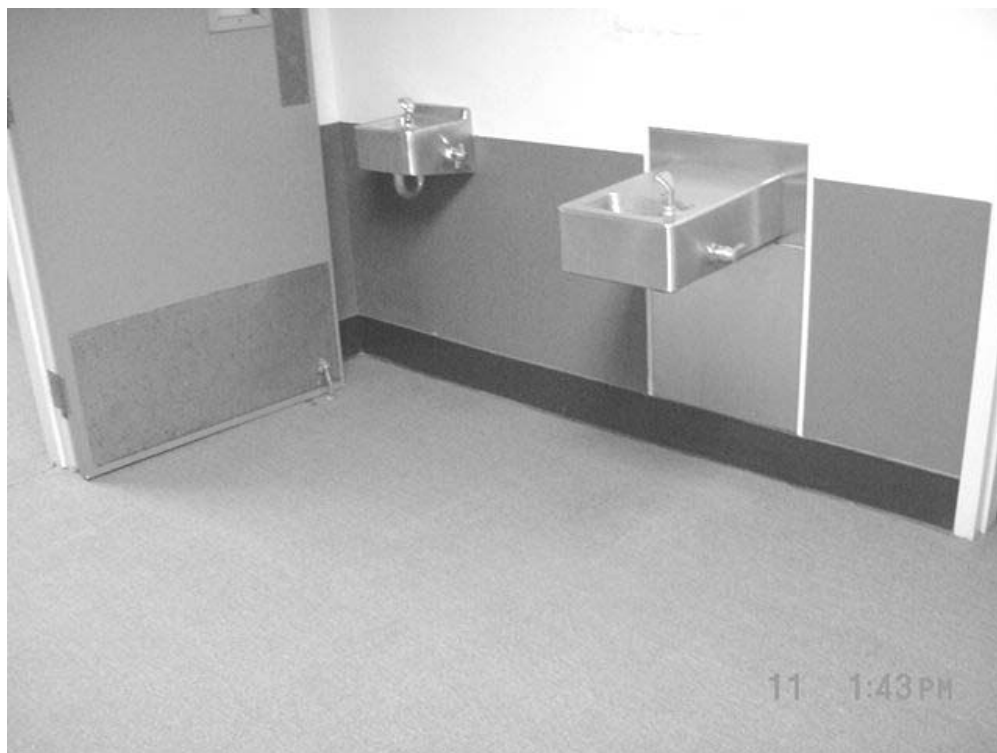
Picture 5

Several areas had water fountains installed over carpeting (see Picture 5). Water spillage or overflow due to drain blocks can result in the wetting of the carpet. As previously mentioned, if carpeting is not dried within 24 hours of becoming wet, mold growth may occur.

Water Fountains over Carpeting

9. Remove sections of carpeting or place rubber/plastic matting beneath water fountains to prevent water damage and potential for mold growth.
10. Keep plants away from univents in classrooms. Ensure plants have drip pans, examine drip pans for mold growth and disinfect areas with an appropriate antimicrobial where necessary.

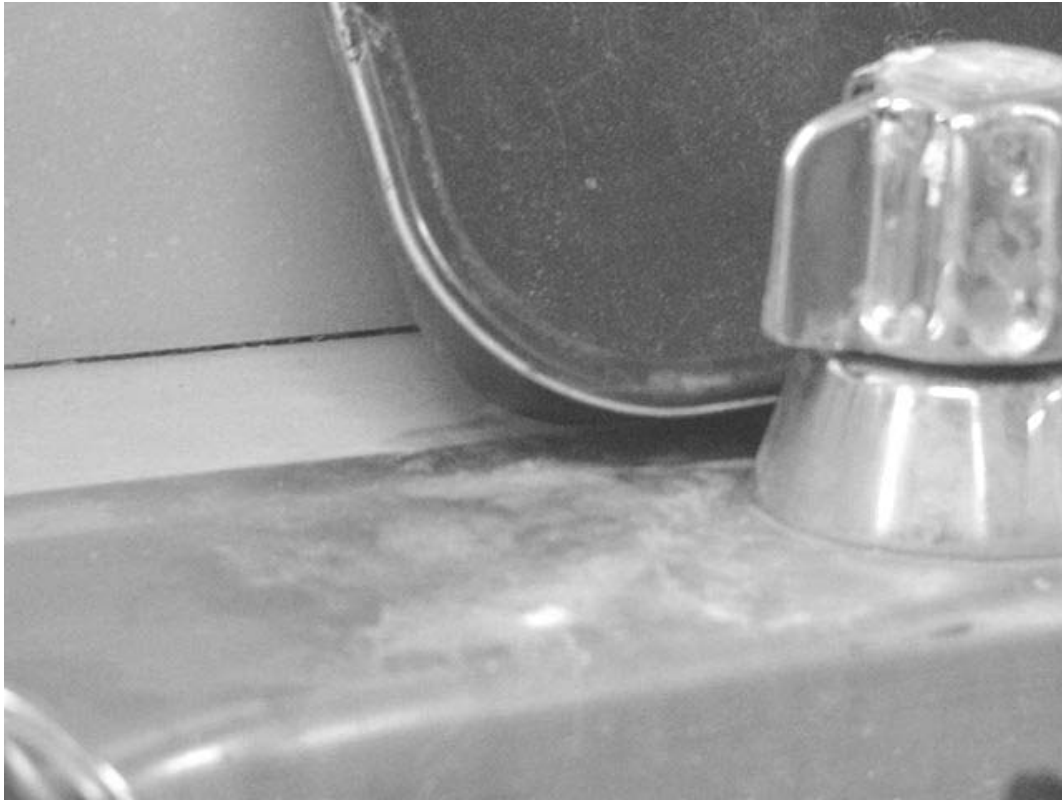
Picture 6

Spaces between the sink countertop and backsplash were noted in a number of classrooms (see Picture 6). A leaking faucet was noted in classroom 9. Repeated leakage or improper drainage/overflow of water in sinks can lead to water penetration/damage of countertop wood, the cabinet interior, areas behind cabinets and carpeting. Like other porous materials, if these materials become wet repeatedly they can provide a medium for mold growth.

Space Between Backsplash and Sink Countertop in Classroom
